## 9 Environmental

### 9.1 Site Overview and History

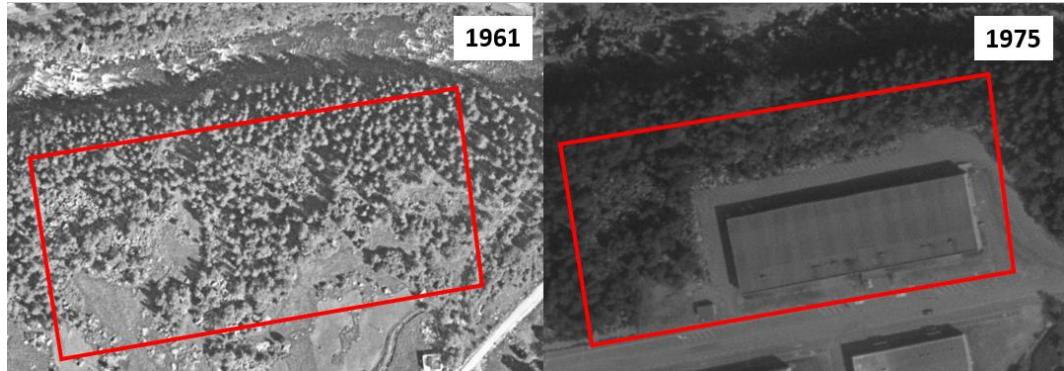
Figure 8 - Historical site use (1961 & 1975). Source Norge I Bilder.

Historical aerial imagery suggests that industrial developments were established in the area during the 1970s, refer to Figure 8 below. A warehouse building was built on the study site and the building was gradually extended over the next 40 years, see Figure 9 for the years 2002 and 2013.

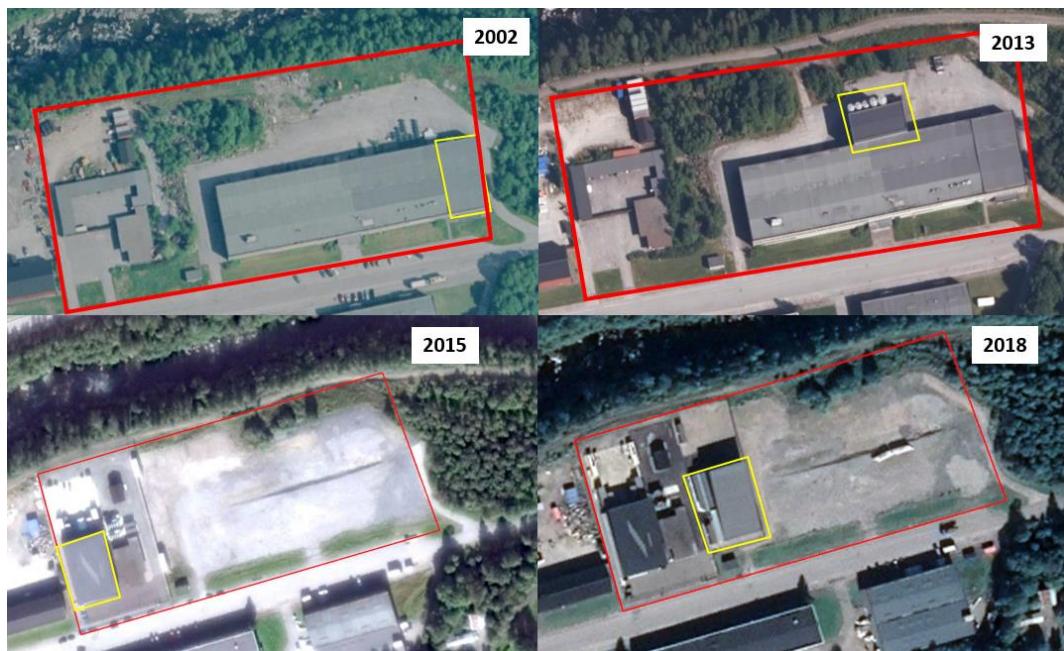
Figure 9 Historical site use. Source: 2002 & 2013 Norge i Bilder; 2015 & 2018 Google Earth.

Aerial imagery shows that the warehouse was demolished by 2015 and new warehouse buildings were constructed, refer to Figure 9. Aerial imagery from 2018 shows an additional warehouse has been built on the study site. Figure 10 below shows the site layout in 2020.

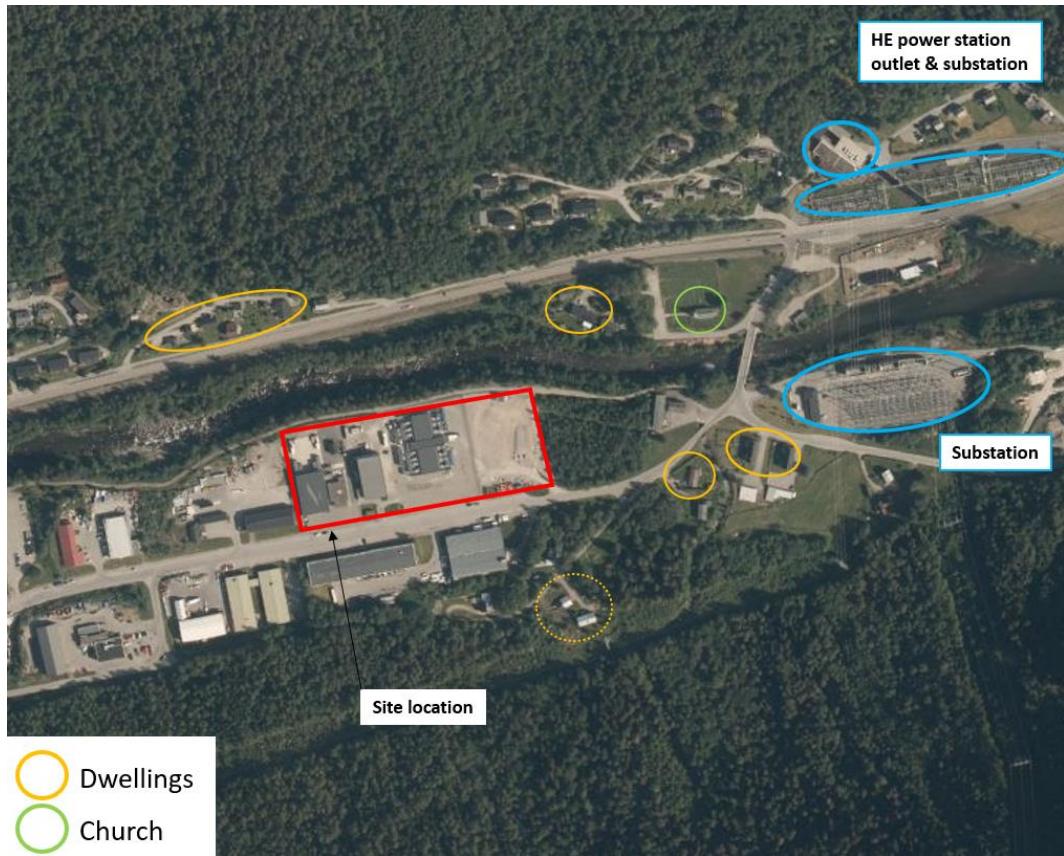
Figure 10 Surround site use. Image taken in 2020. Source Norge i Bilder.

The study site is located in an industrial area, Svadde Industriområde in Rjukan. There are some sensitive receptors such as dwellings and church in proximity (<200m) to the study site boundary to the east, refer to Figure 10 below. Such receptors may be sensitive to noise or air emissions from the site. Refer to Section 7.7.1 for a summary of a noise assessment carried out at DC2.

There are two substations east and north east of the study site, refer to Figure 10. The outlet point for the hydroelectric station and substation is also north east of the study site.

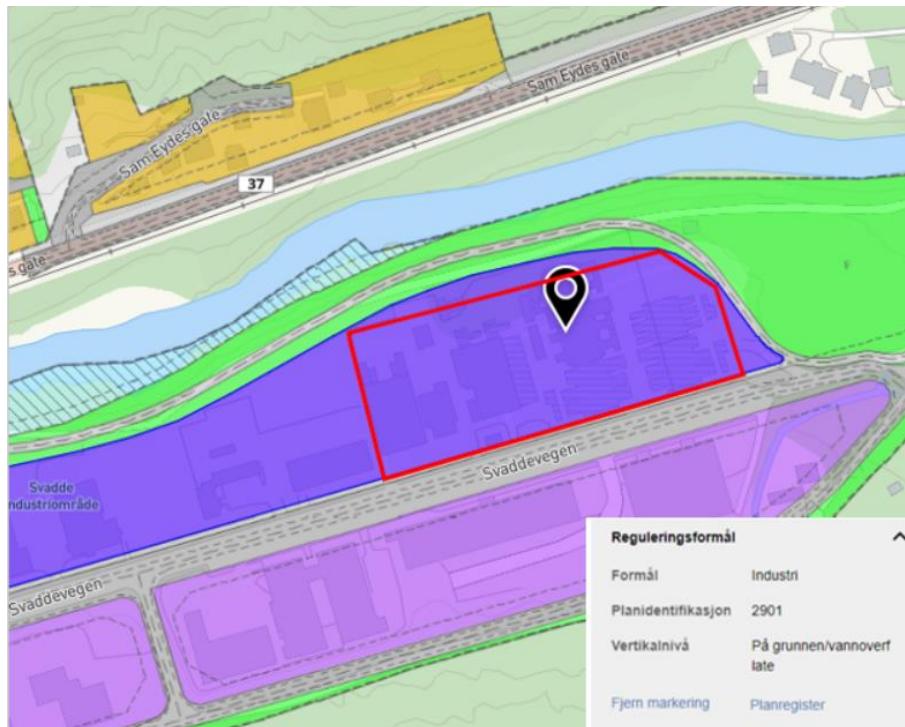
Figure 11 Zoning Plan. Source KommuneKart, Norkart.

The study site is located in an area zoned 'I2' for industry, refer to Figure 11 below.

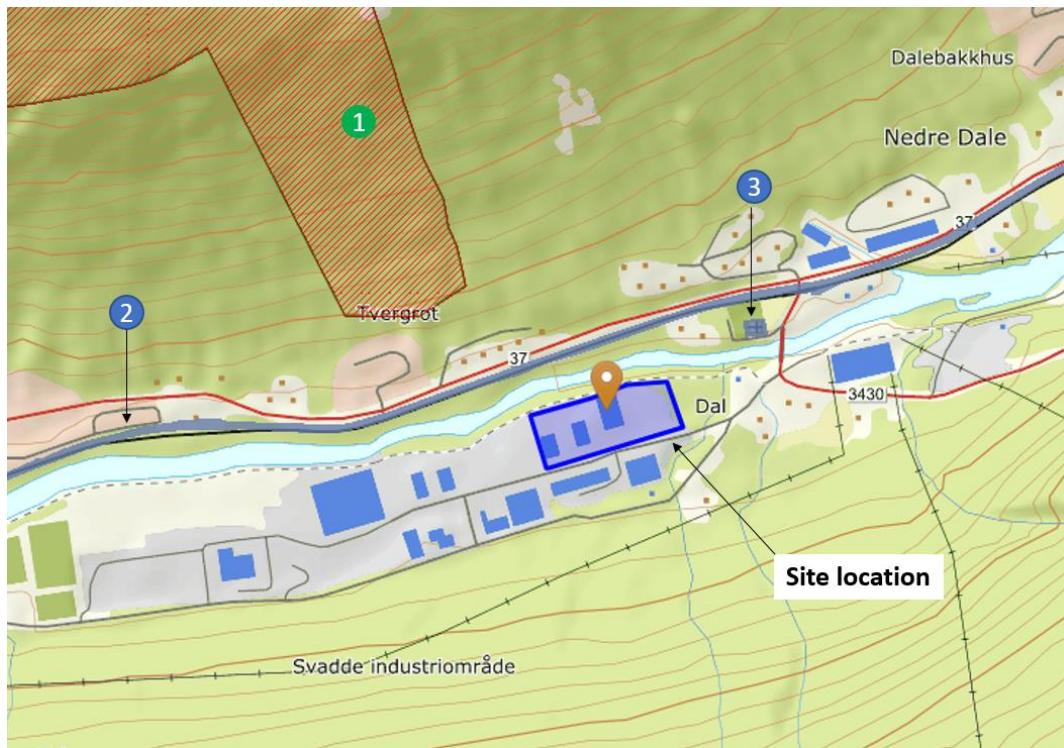
Figure 12 Protected natural and cultural heritage sites. Source: Økologiske Grunnkart.

There are no protected conservation areas or proposed conservation areas within or in proximity to the study site. The nearest protected site is the Overland Nature Reserve, approximately 250m northwest of the study site boundary, see No. 1 in Figure 12.

- Rjukanbanen - Tinnoset-Vemork - railway that runs parallel to the Skiensvassdraget river on the northern bank, see No. 2 in Figure 12. Activity on the railway line was discontinued in 1991.
- Dal Kirkestad (church) – see No. 3 in Figure 12. According to Kulturminnesøk records<sup>2</sup>, the cultural protection status of the church is recorded as ‘unclear’ (“Uavklart”) however it is noted in the records.
