9 Environmental

9.1 Site Overview and History

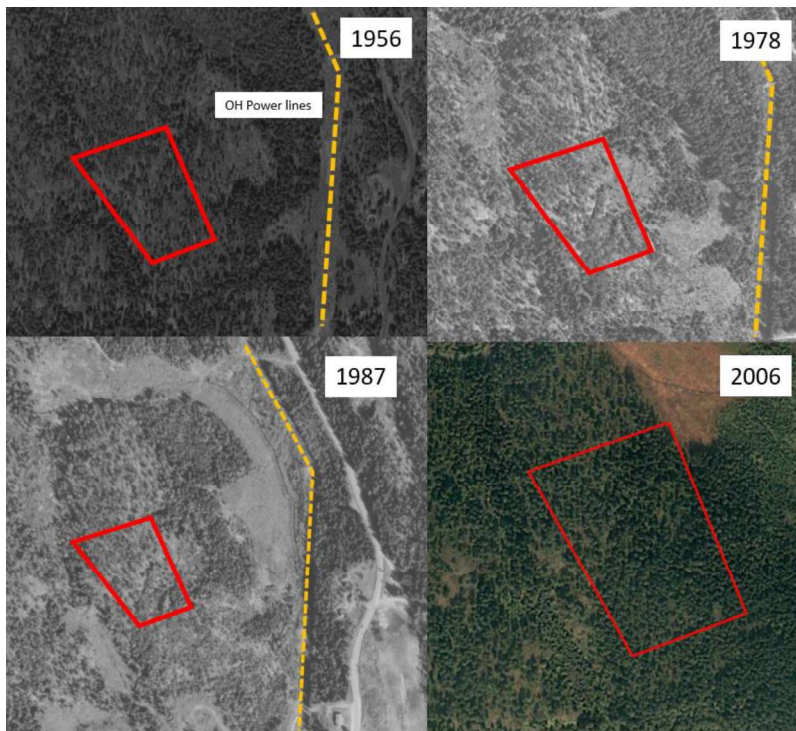
Figure 3 Aerial photography of the site. Source: 1956-1987 Norge Bilder; 2006 Google Earth.

The site was previously undeveloped with no significant changes to the forest land cover noted in the available aerial mapping from 1956 to 2006. The overhead powerline had been established by 1956 and is located approximately 170m east of the site, refer to Figure 3 .

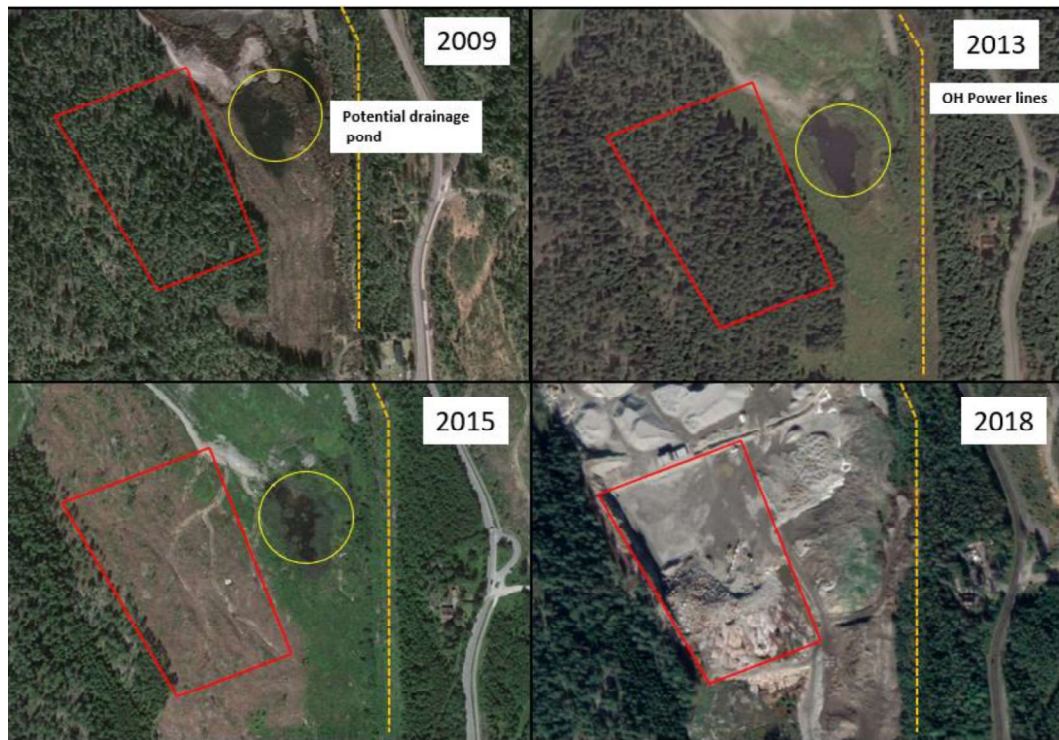
Figure 4 Aerial photography of the site 2009 -2019. Source: Google Earth.

Development on the land north of the study site began in 2003 and was extended gradually southwards to the study site. The site was cleared of forestry in 2015 (Google Earth). The area east the site appears to have been used as a drainage pond for runoff from the construction compounds north of the site, refer to Figure 4 for 2009-2015. By 2018, the drainage pond appears to be infilled (Figure 4).

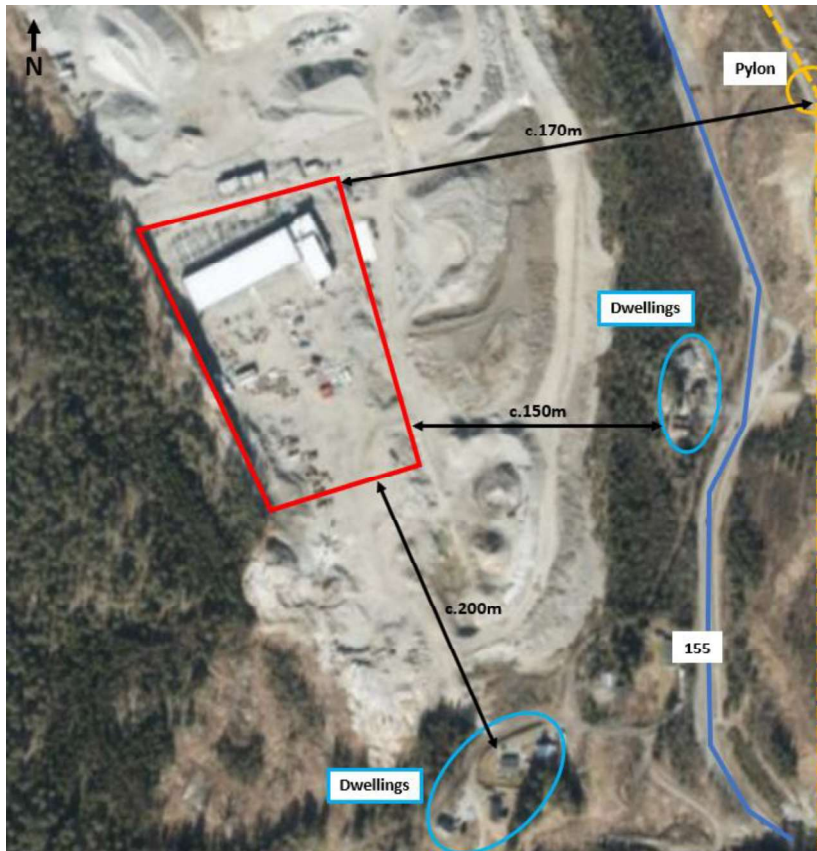
Figure 5 Surrounding site use. Source Norge Bilder (2020).

There are two clusters of dwellings east and south of the site approximately 170m and 200m respectively, refer to Figure 5 Surrounding site use. Source Norge Bilder (2020).below. These are relevant with regard to sensitive receptors in terms of noise and air quality emissions.

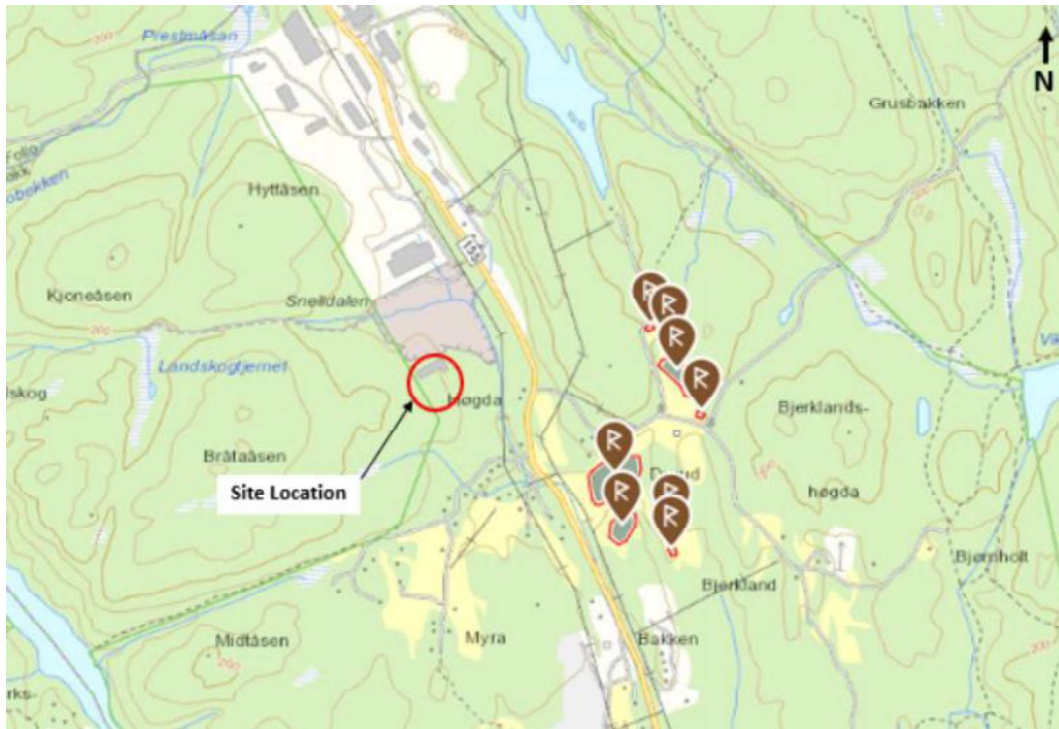
Figure 7 Protected cultural sites. Source Kulturminnesøk.

The Kulturminnesøk online mapping was reviewed for cultural sites in proximity to the site. There are no protected cultural sites within or in proximity to the study site. The nearest sites are approximately 700m east and south east of the study site, refer to Figure 7 below. The cultural sites are described as cultivation tracks and settlement areas.

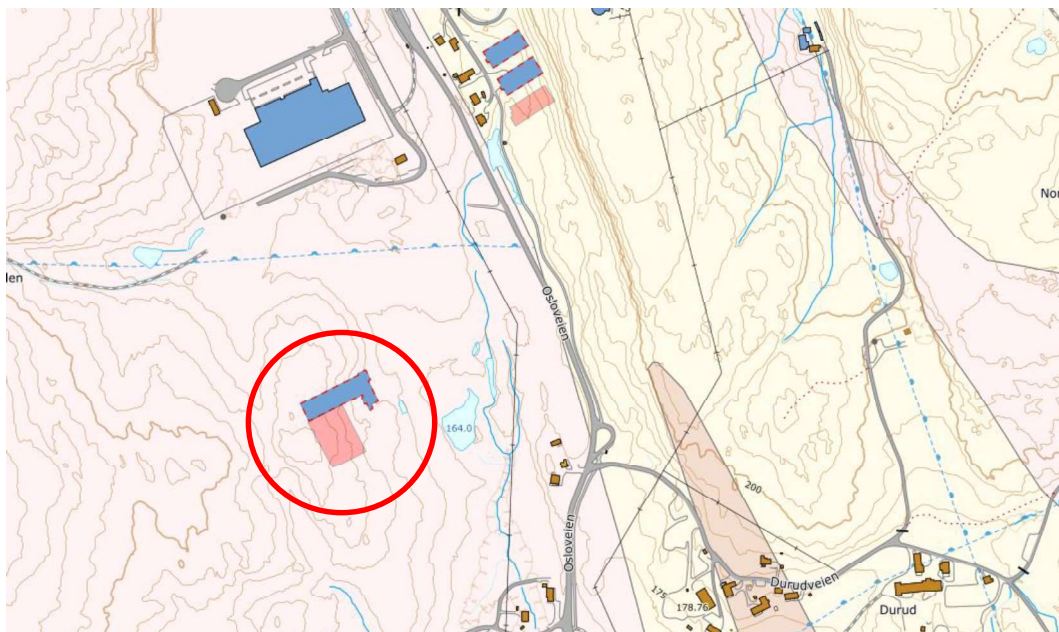
Figure 11 Bedrock map from NGU [4], legend: pale pink – granodiorite augen gneiss.

The bedrock in the area primarily comprises gneiss, see Figure 11. Groundwater wells in the area indicate that groundwater is found in the bedrock fracture system, often at shallow depths.
